# IZH-46M Repair: Breech Block Lever Won't Stay Up

M.I.T. Sport Pistol Club

Doug White, 12/26/13

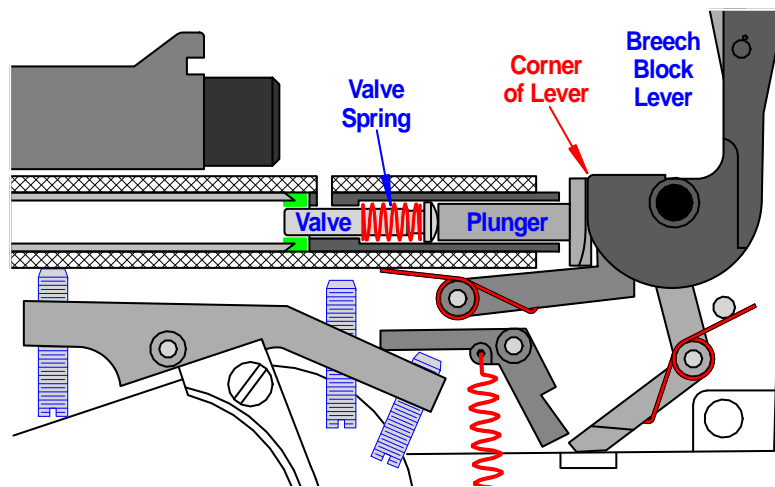
Figure 1 shows the various parts involved. When the breech block lever swings up towards its vertical position, the lower front corner of the lever cams the Plunger (#17) forward, closing the Valve (#9). The Valve Spring (#13) holds the plunger against the bottom of the breech block lever (which is now vertical). As long as there is enough rearward force on the corner of the lever, the plunger should prevent the lever from rotating forward.

Figure 1: Geometry of valve, spring, plunger and breech block lever

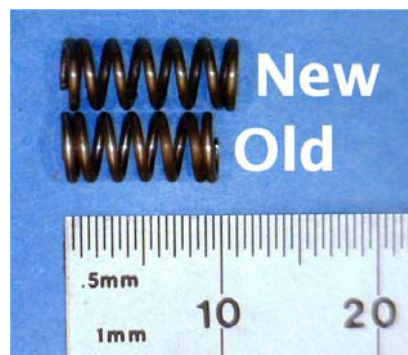
Figure 2: Old and new valve springs

The old spring is considerably shorter than a new one, and there is also a small bit of wear that would weaken it further. The wire size and number of turns appear to be identical, so it is quite possible that the old spring started out life as long as the new ones. The pistol certainly didn't have a problem with the breech block flopping down when it was new.

Apparently the spring has shortened over time. This may be the result of improper heat treating, but it is likely that the problem is aggravated by the way the pistols are stored. They are kept in racks with the actions fully open (breech block lever vertical), which means the springs are kept almost fully compressed. This could cause them to slowly take a "set" over time, and to end up in the shortened condition seen here. We have about fifteen IZH's, and only a couple have developed this issue, so there are clearly some other variables at work.

Replacing the spring with a new one restored the pistol to normal operation. It's likely that stretching the old spring back to its nominal length would also do the trick. We will have to modify our storage procedures to require lowering (but not closing) the breech block lever, and then releasing the trigger. This will ensure that the valve spring is stored in a relaxed condition.
